**Addendum:  
WATER QUALITY MONITORING AND ASSESSMENT  
HYDROGEOLOGICAL ASSESSMENT  
Proposed Drainage District #88**

**Report to the Dodge County Circuit Court**

## **Addendum:**

### **Re: Montgomery-Settersten Report on Proposed Dodge County Drainage District 88**

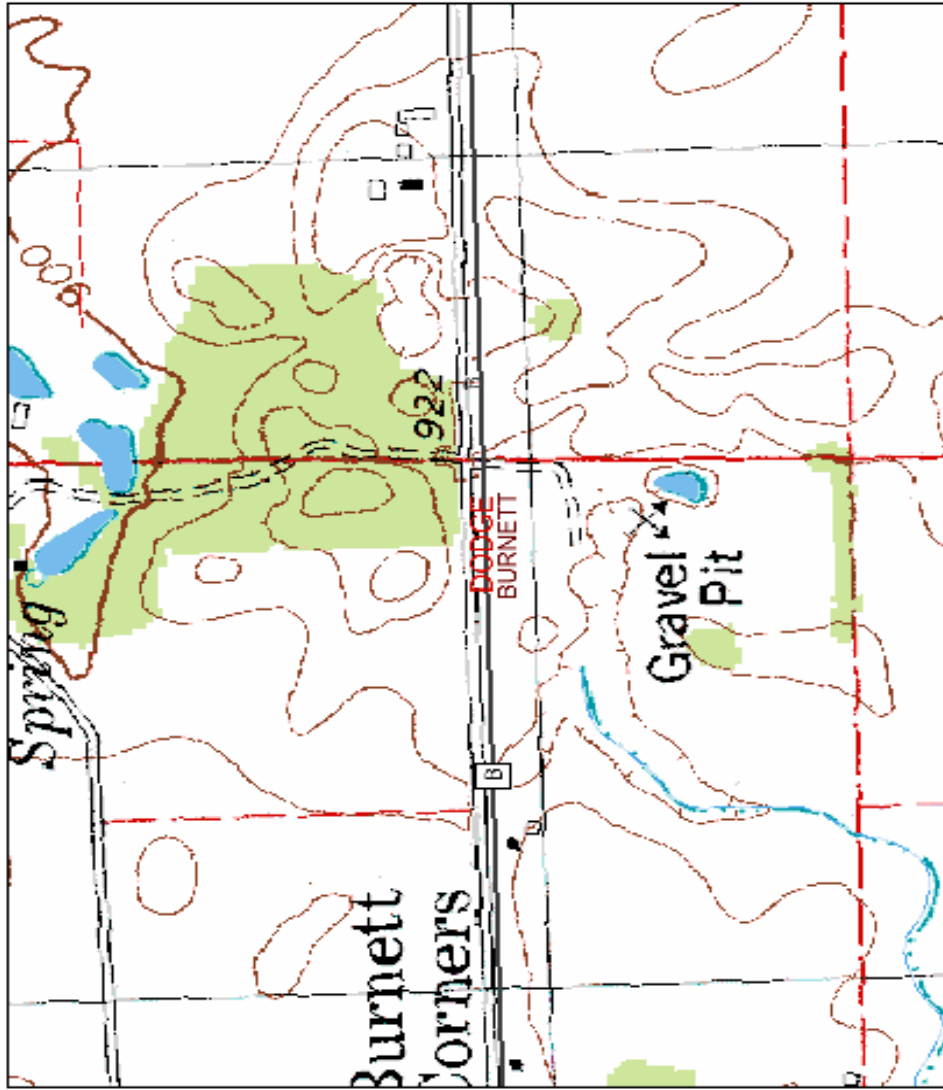
Figure 1. Gravel Pits at Historic DCAPC Site

Figure 1 is an archival topographic map of the historic DCAPC site with the gravel pit area clearly identified. The area was about 5 acres in size with two large pits. The map also shows the path of overland flow terminating on site. The authors of the Report appear to have either overlooked this information or not considered its significance.

Notes: Map contours with designated gravel pit area and waterway ending on pit development site.

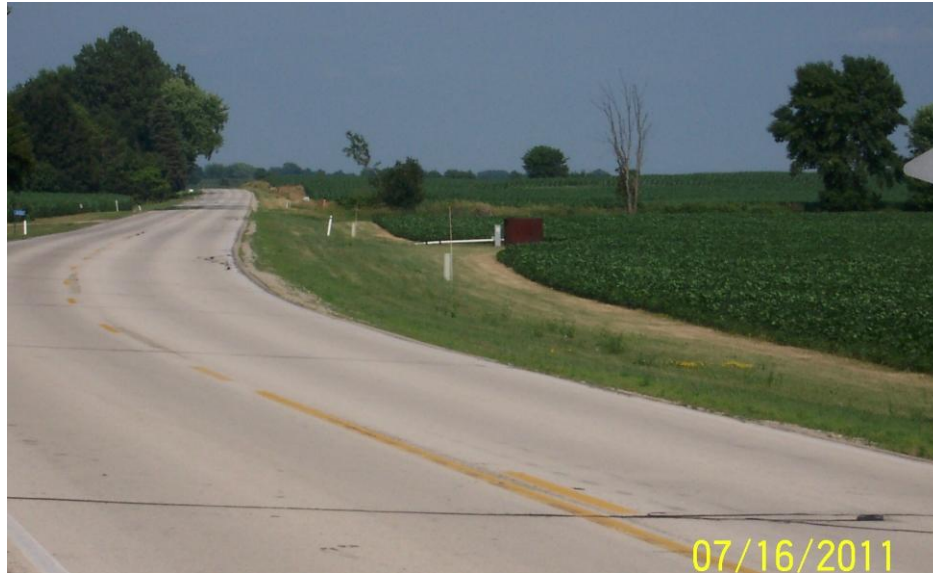
Active pit drainage is found just west of the western boundary of the proposed drainage district on Highway B before Basswood Road. On the south side of Highway B is a large field sump that receives drain tile water (Figure 2). A drainage pump conveys the drain water through PVC under the highway to a field drain. We understand the drain water then flows by gravity to a gravel pit that also receives surface runoff from the field.

Figure 2. Field sump with drainage pump and PVC transfer pipe on the south side of Highway B, Town of Beaver Dam.

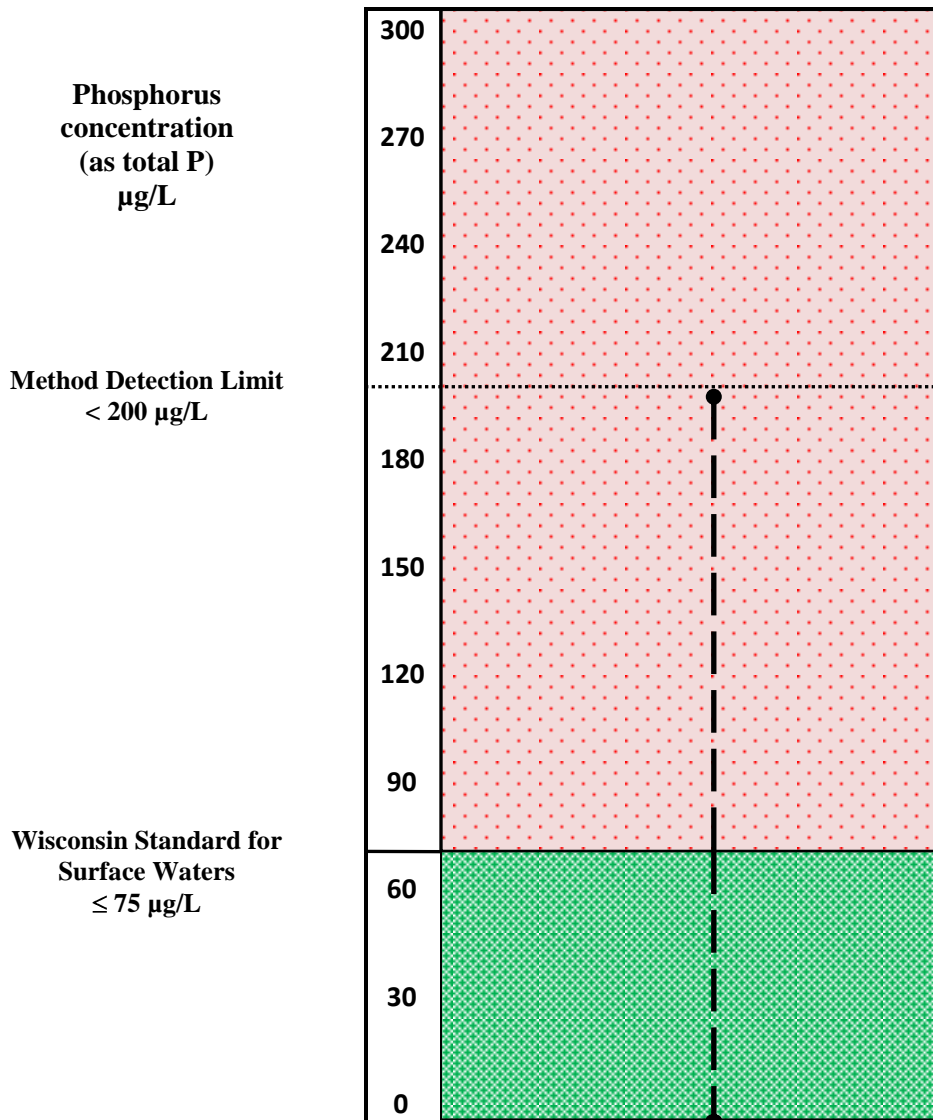
The relevance of MDL in assessing water quality may be demonstrated by Figure 3. Shown on the Y axis with phosphorus concentration in  $\mu\text{g/L}$  are the Method Detection Limit of  $< 200 \mu\text{g/L}$  and the Wisconsin standard for phosphorus in surface water of  $\leq 75 \mu\text{g/L}$ . The vertical dashed line covers the range of phosphorus values that are less than  $200 \mu\text{g/L}$ . Note that the federal definition of MDL with 99 % confidence means that a sample with phosphorus assay as high as  $199 \mu\text{g/L}$  must be reported as  $< 200 \mu\text{g/L}$ .

Figure 3. Method Detection Limit (MDL) and Wisconsin standard for surface waters for phosphorus (as total P). Phosphorus values within the red zone exceeded the state standard of 75  $\mu\text{g/L}$ , while values within the green zone are at or below the state standard.

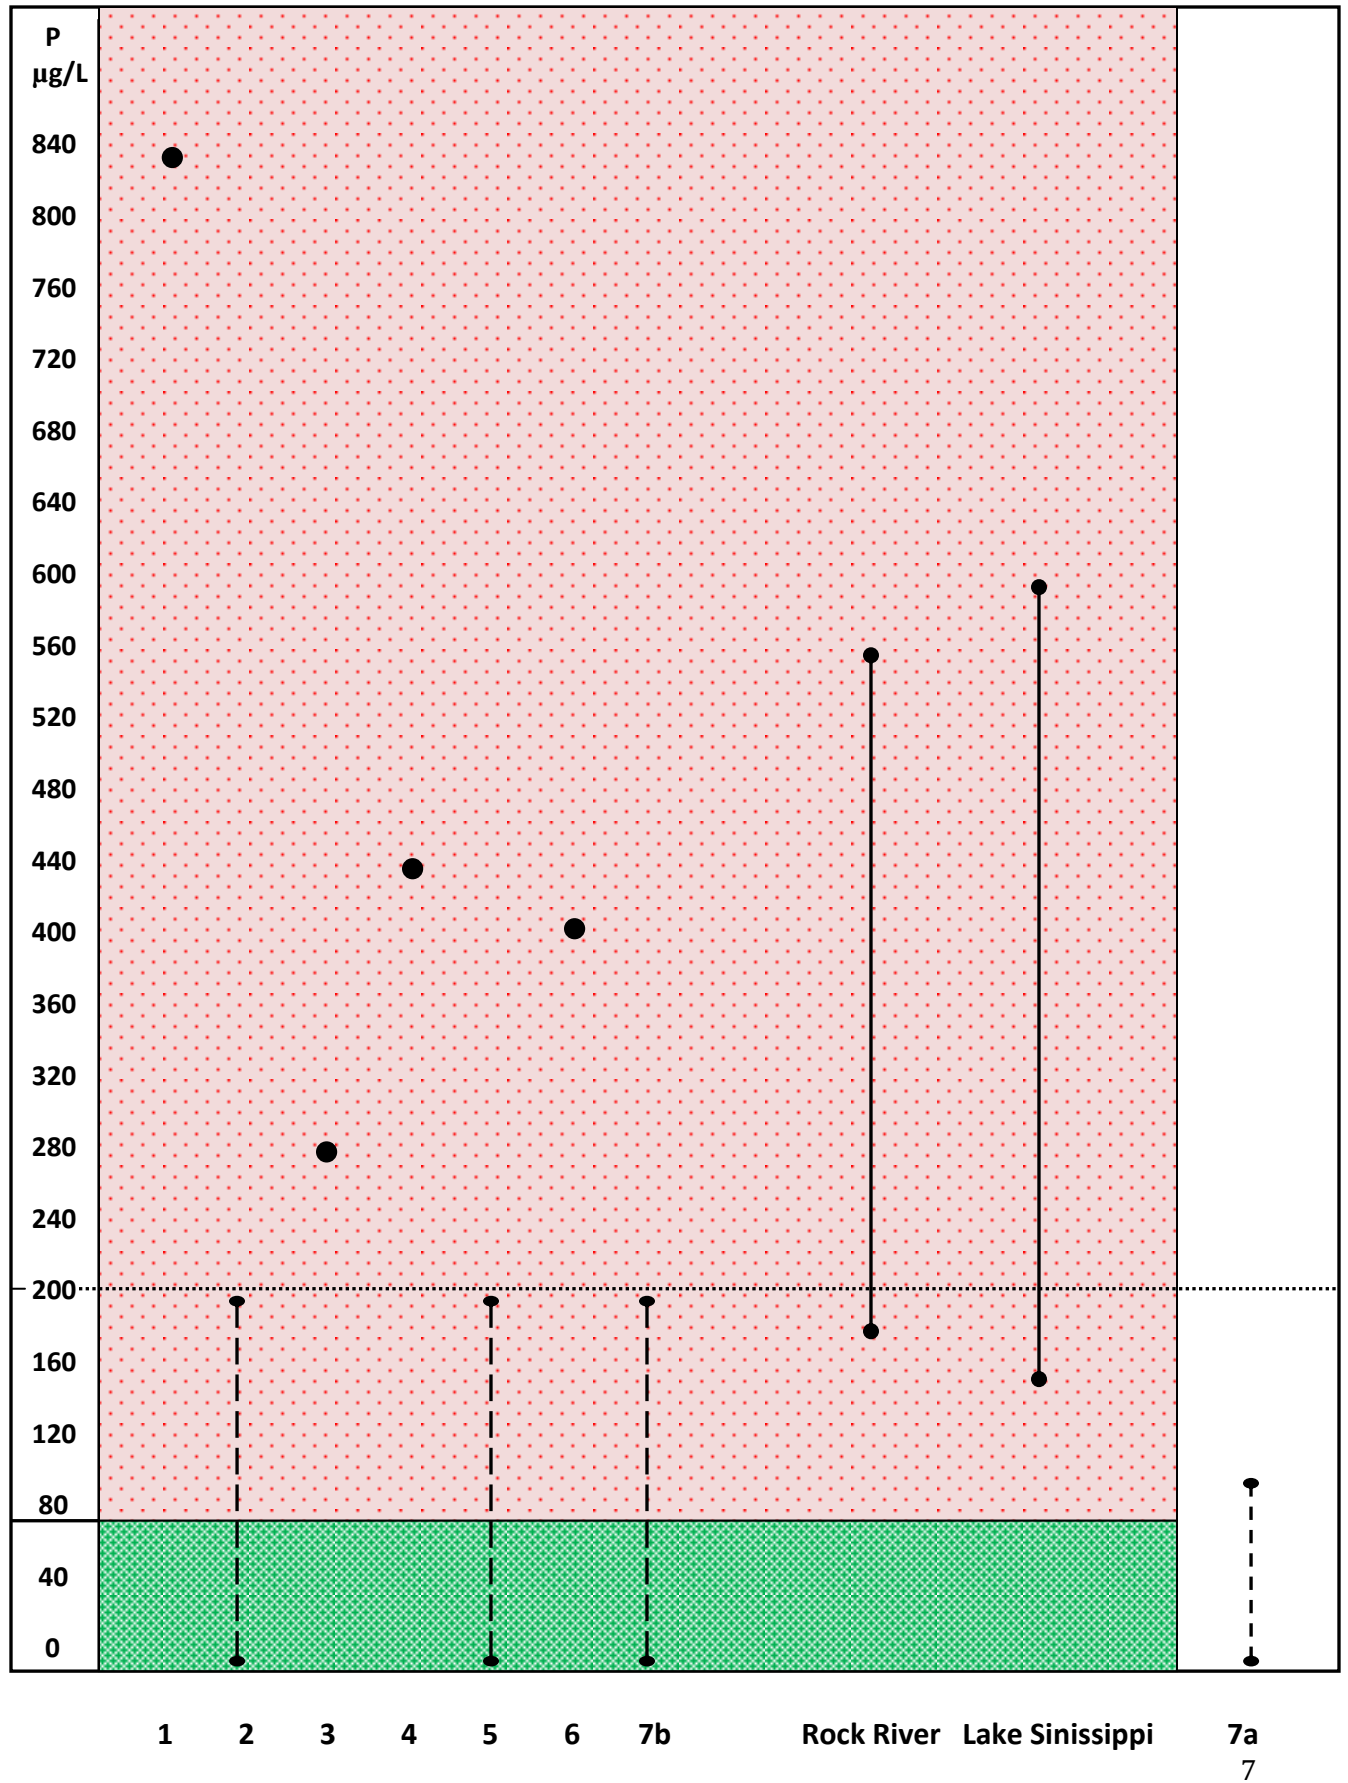
Phosphorus values given in the Lake District water quality report on District 88 are shown in Figure 4, along with the range of phosphorus concentrations in the Rock River and Lake Sinissippi as reported by the US Geological Survey and the Lake District. Sampling site 7a is the spring water (ground water) that flows into the first pond at Spring Brook Farm. The MDL indicates that the value of phosphorus in a sample reported as  $< 200 \mu\text{g/L}$  is likely to exceed the state standard, since the probability of the true value exceeding the state standard (red zone) is greater than the probability of the value being at or below the standard (green zone).

The data clearly demonstrate that there is a phosphorus problem in district drain waters. The sample from Site 1 is in excess of 1,100 % of the state standard. Additionally, the magnitude of the reportable values (*i.e.*, those values greater than the MDL) strongly suggest that the true value of samples reported as being below the MDL would likely fall very close to the MDL, especially since the lowest reportable datum of  $260 \mu\text{g/L}$  is 347 % greater than the state standard.

Figure 4. (below) Phosphorus Concentrations ( $\mu\text{g/L}$ ) at Drainage District 88 Sampling Sites, Spring, Pond, River and Lake

The Rock River and Lake Sinissippi are on the EPA 303(d) list of impaired waters for reason of nutrient enrichment and both are under state management plans to correct deficiencies and reduce phosphorus and nitrogen values. The message of Figures 4 and 5 is that unless and until nutrient loads in watershed runoff, such as that from proposed District 88, are reduced substantially, the Rock River, Lake Sinissippi and other surface waters will remain seriously impaired.

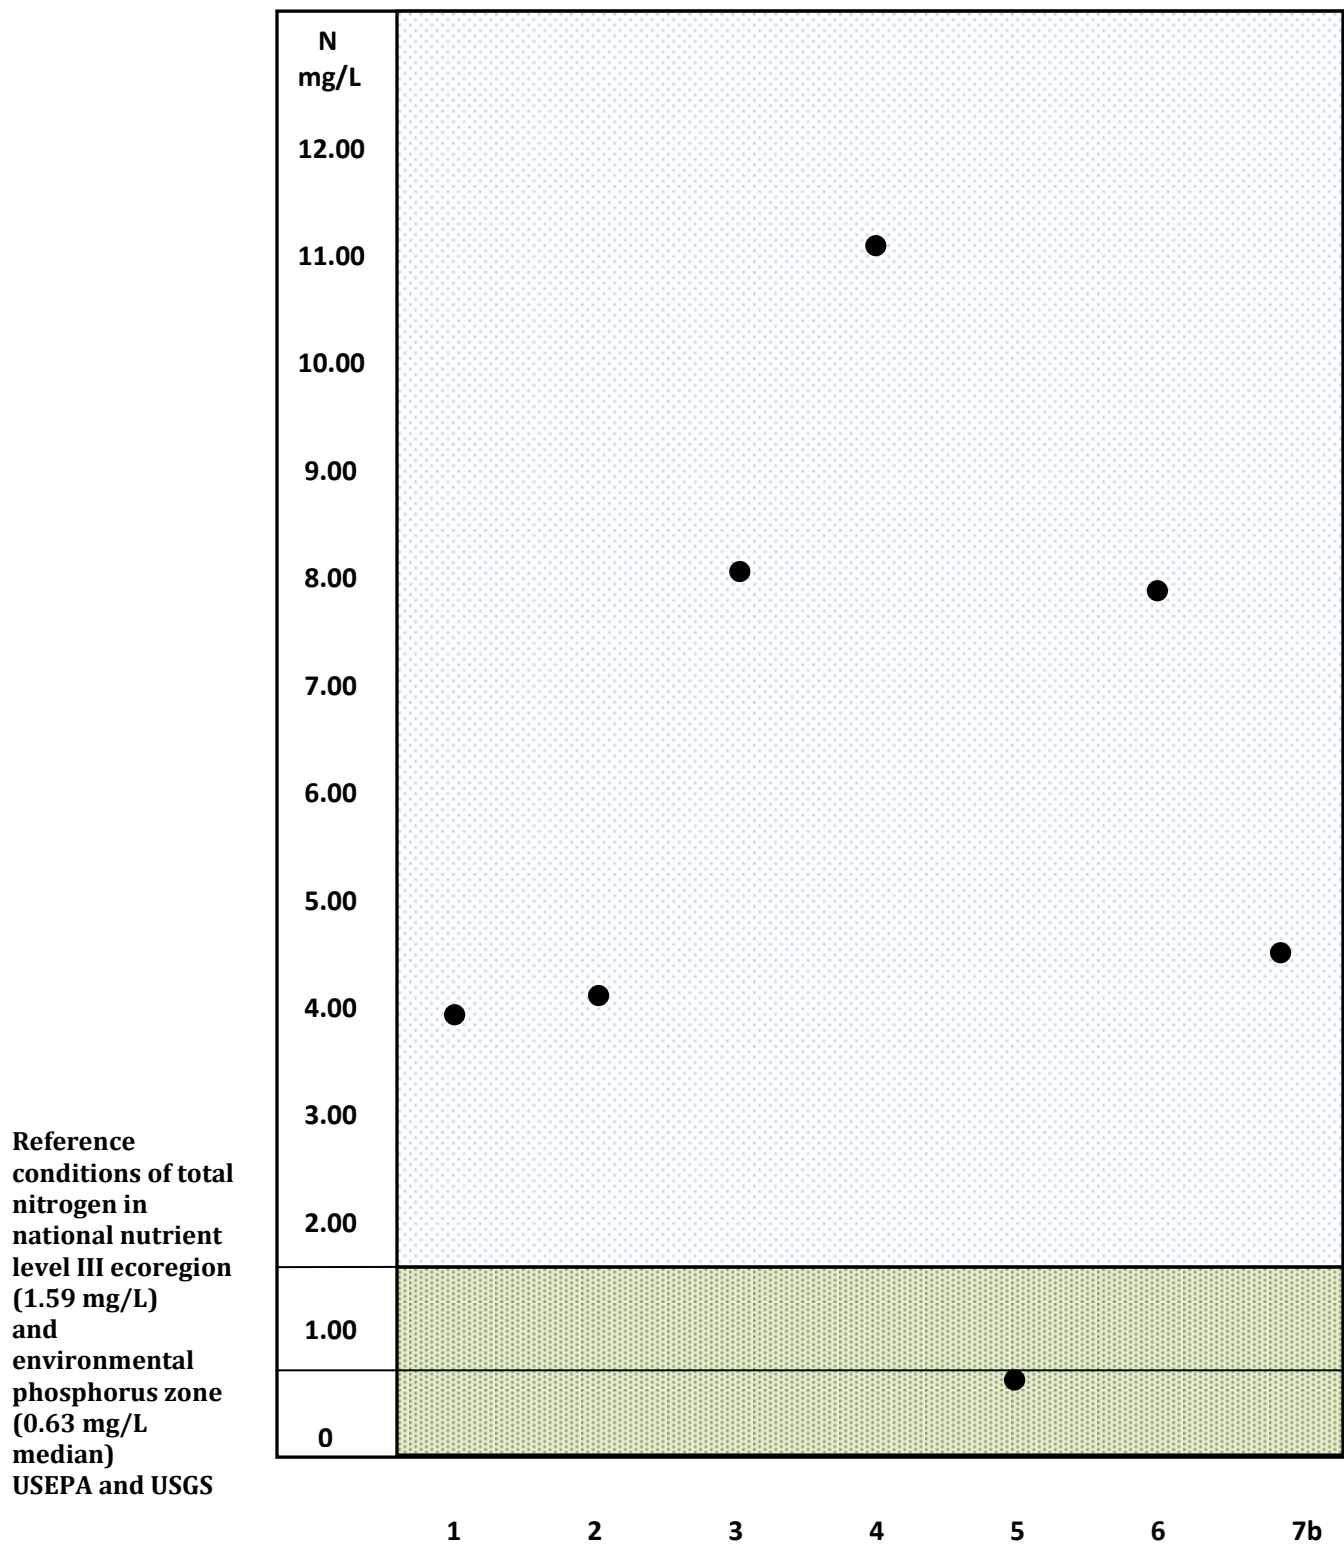
Figure 5. Total nitrogen concentrations (mg/L) at Drainage District 88 Sampling Sites and Spring Pond.

Nitrogen values in samples collected in the proposed district are shown in Figure 5. On the Y axis are values of total nitrogen (total Kjeldahl nitrogen plus nitrate and nitrite nitrogen) in mg/L at each sampling site. Also shown are the reference concentrations for total nitrogen in national level III ecoregion 53 (1.59 mg/L) and environmental phosphorus zone 2 (0.63 mg/L) (Sources: US Environmental Protection Agency 2000 and Robertson, D M *et al*, 2006). Nitrogen values in drain water of the proposed district dramatically exceed federal reference conditions. The sample from Site 4 is 700 % of the reference value. (Given the high nitrogen values in the other samples, the low value at site 5 is probably an anomaly; however, there was an insufficient volume of water available for a re-test.)

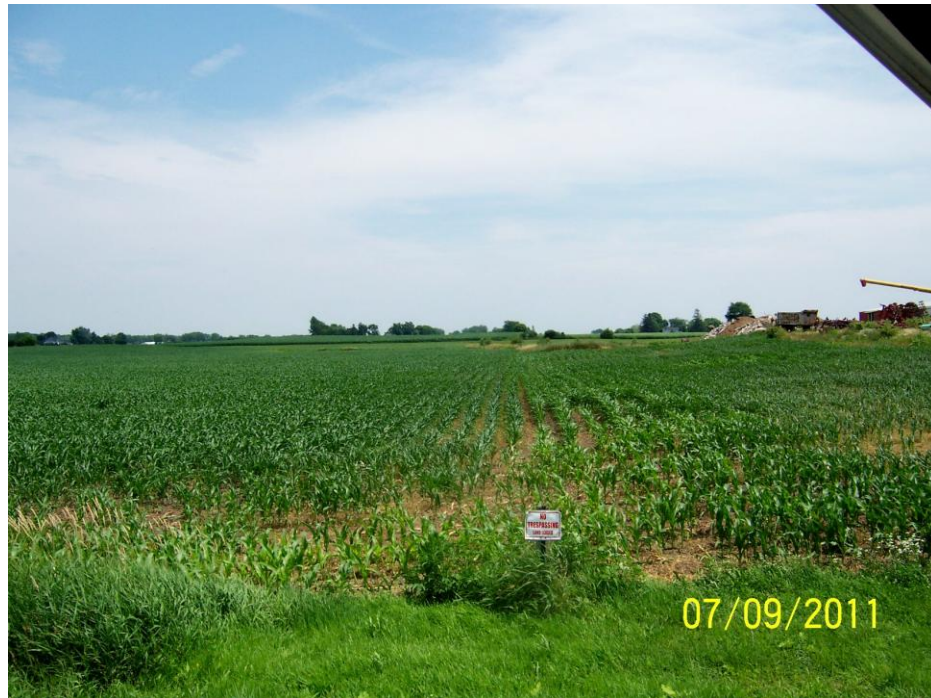
A recent drive through the watershed of the proposed district revealed that the same cropping practices are still being implemented by the landowners. Figure 6 is a photograph looking east from the Butternut Road culvert showing that land designated as the district drainage way was cultivated and planted with corn, an apparent violation of Chapter ATCP 48 provisions.

Figure 6. Looking east from Butternut Road showing that land designated as the drainage way for District 88 is planted in corn.

Land use practices shown in Figures 6-8 appear to violate provisions of Chapter ATCP 48 and would not be permitted under the water quality management plan envisioned in the Report. The fact that landowners within the proposed district have implemented such practices reinforces our belief that monitoring, inspection and enforcement of conditions in any approved plan are essential.

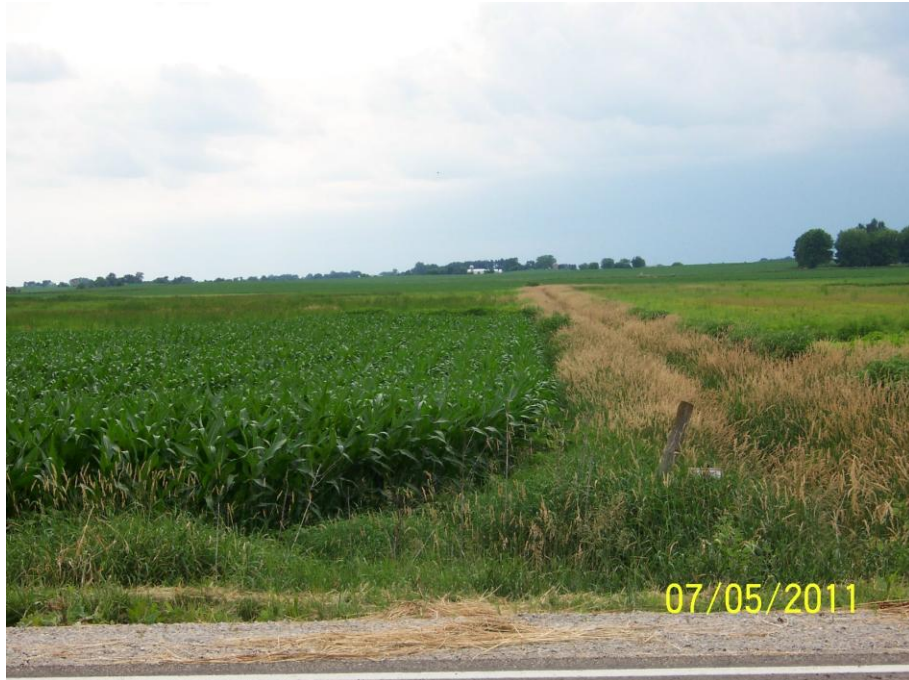
Figure 7 is a photograph taken at the culvert on Highway I, looking west, showing that corn is planted within a 20-ft corridor along the drainage ditch and with no evidence of erosion control measures to protect water quality. These practices do not comply with provisions of Chapter ATCP 48.

Figure 7. Looking west from Highway I showing corn planted less than 20 feet from the drainage ditch and with no erosion control measures.

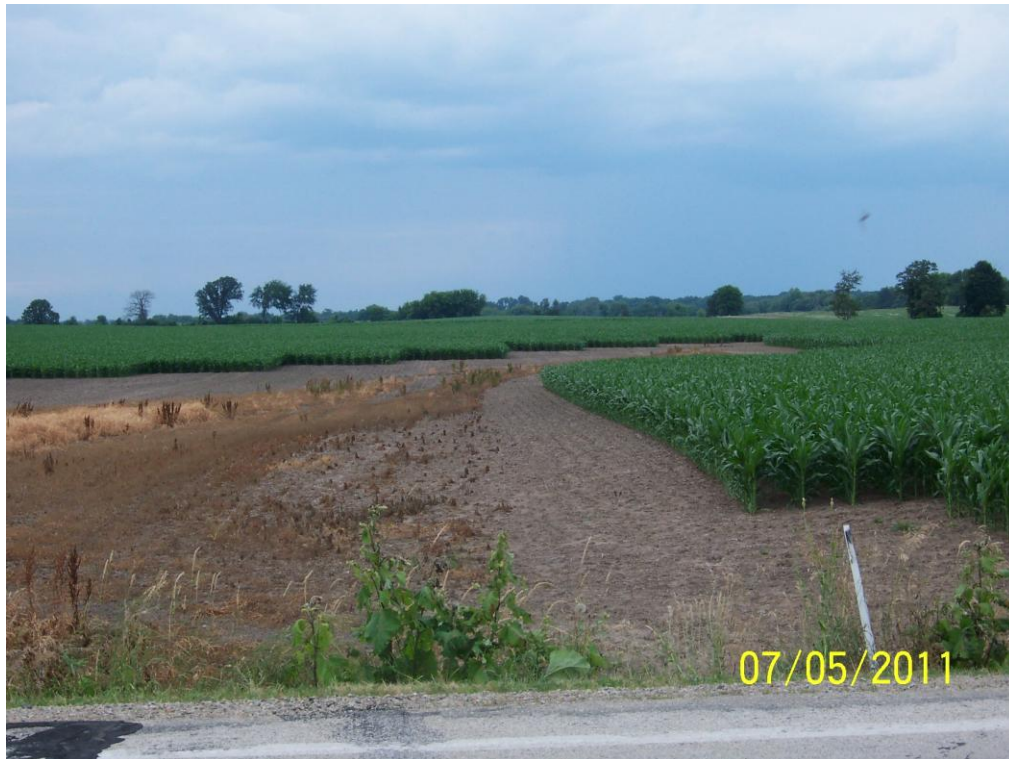
In addition, a portion of the field lying north of the Highway B culvert within the proposed drainage way has large unplanted areas on either side of what appears to be an herbicide-treated zone (Figure 8). The unplanted areas remain as bare soil with no cover vegetation, highly susceptible to erosion from rainfall, runoff from the corn acreage and drain water flowing through the culvert down gradient to the spring ponds.

Figure 8. Looking north from culvert at Highway B showing the drainage way with an herbicide-treated zone near the centerline of the drainage way and bare, exposed soil with no cover vegetation on either side of the centerline.
